TECHNICAL SERVICE BULLETIN

4WD - Intermittent Grinding Noise While Driving

20-2028
11 February 2020

Ford 2013-2018 Expedition
2013-2018 F-150
Lincoln 2013-2018 Navigator

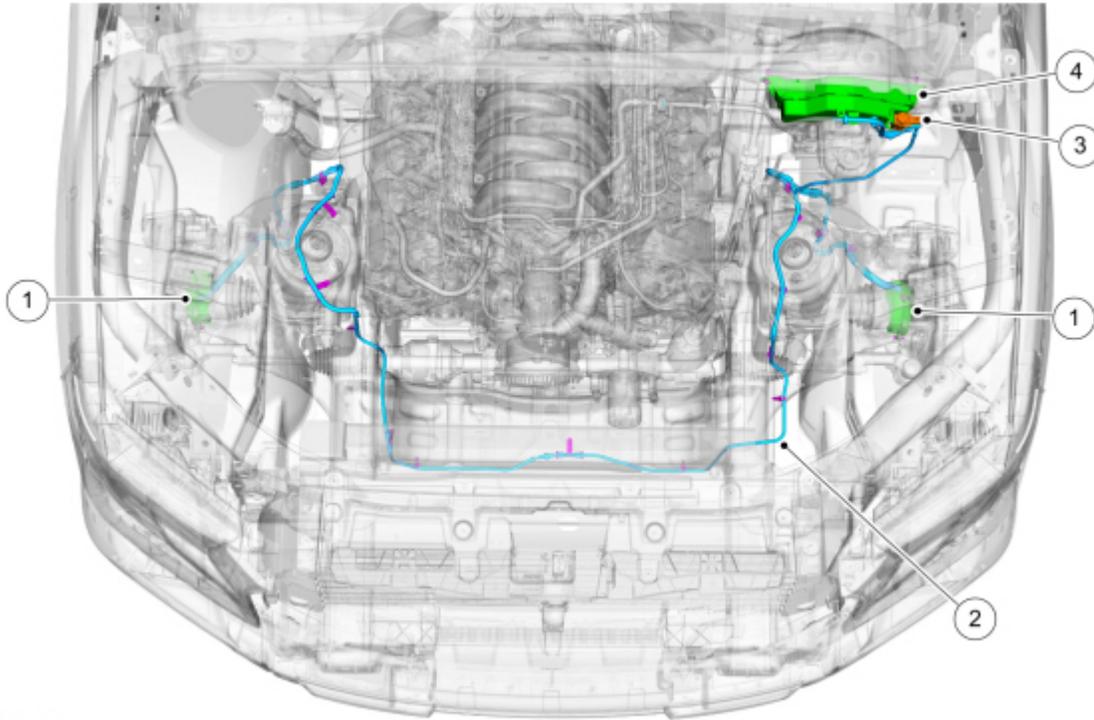
Figure 1

- (2). No - proceed to Step 2.
- 2.** Inspect the IWE vacuum hoses. Refer to Workshop Manual (WSM), Section 308-07A. Are there any disconnected or damaged vacuum hoses? (Figure 1)
 - (1). Yes - reconnect or replace the vacuum hose as required. Refer to WSM, Section 308-07A.
 - (2). No - proceed to Step 3.

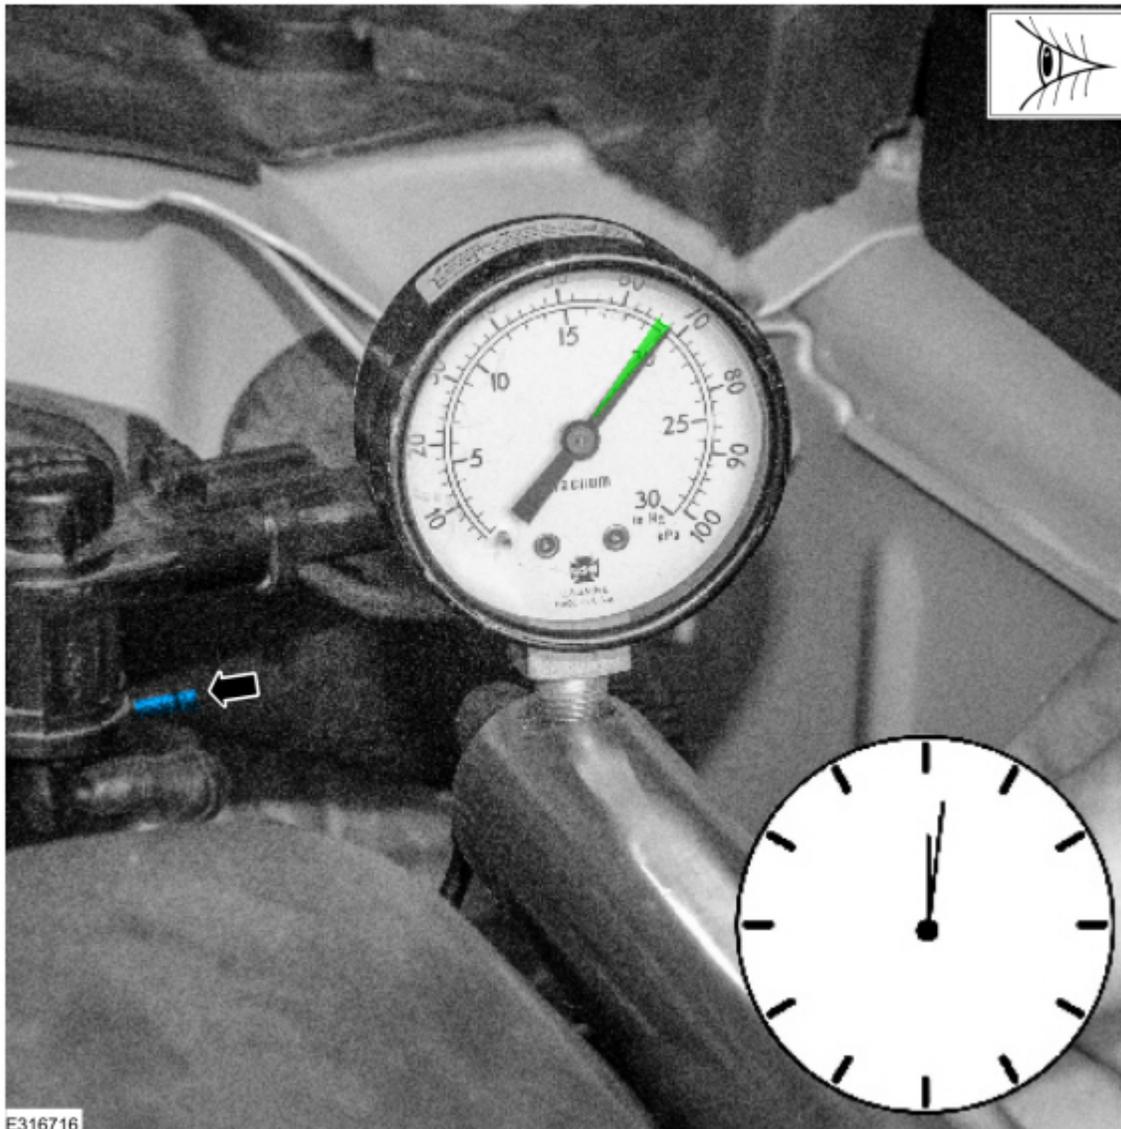
Figure 2

- 3.** Replace the vacuum check valve located near the vacuum reservoir. Refer to WSM, Section 308-07A.
- 4.** Disconnect the vacuum line to the IWEs at the vacuum solenoid.
- 5.** Connect a hand vacuum pump to the IWE vacuum supply line and apply 508 mm-Hg (20 in-Hg) of vacuum. Does the vacuum drop more than 12.5 mm-Hg (0.5 in-Hg) per minute? (Figure 2)
 - (1). Yes - proceed to Step 6.
 - (2). No - connect the IWE vacuum supply line to the solenoid and proceed to Step 10.

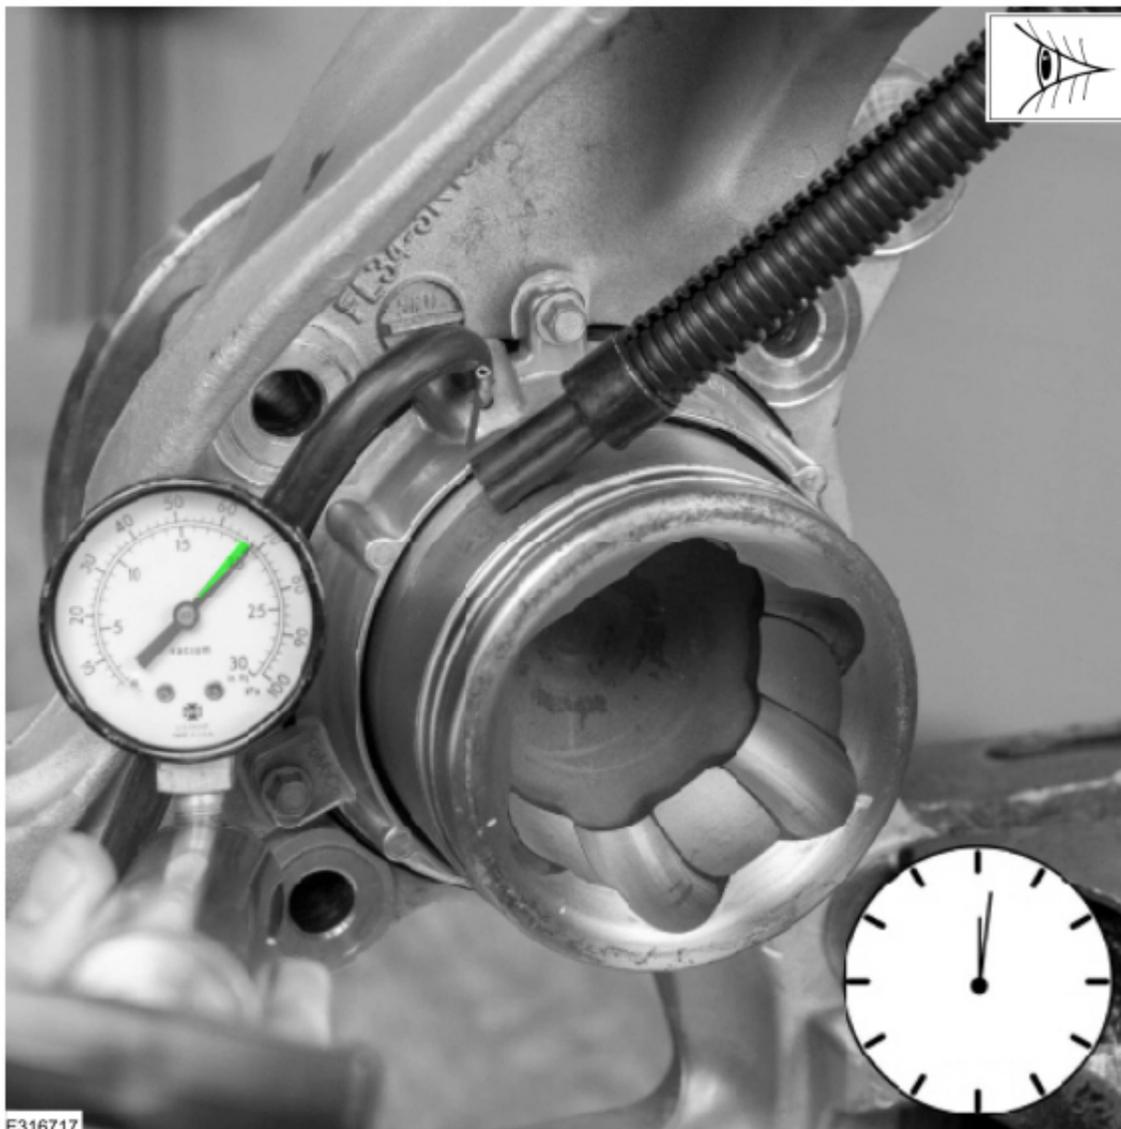
6. Using a hand vacuum pump, apply 508 mm-Hg (20 in-Hg) of vacuum to each IWE, one at a time, and monitor the vacuum gauge. Does the vacuum drop more than 12 mm-Hg (0.5 in-Hg) per minute? (Figure 3)

- (1). Yes - proceed to Step 8.
- (2). No - proceed to Step 7.

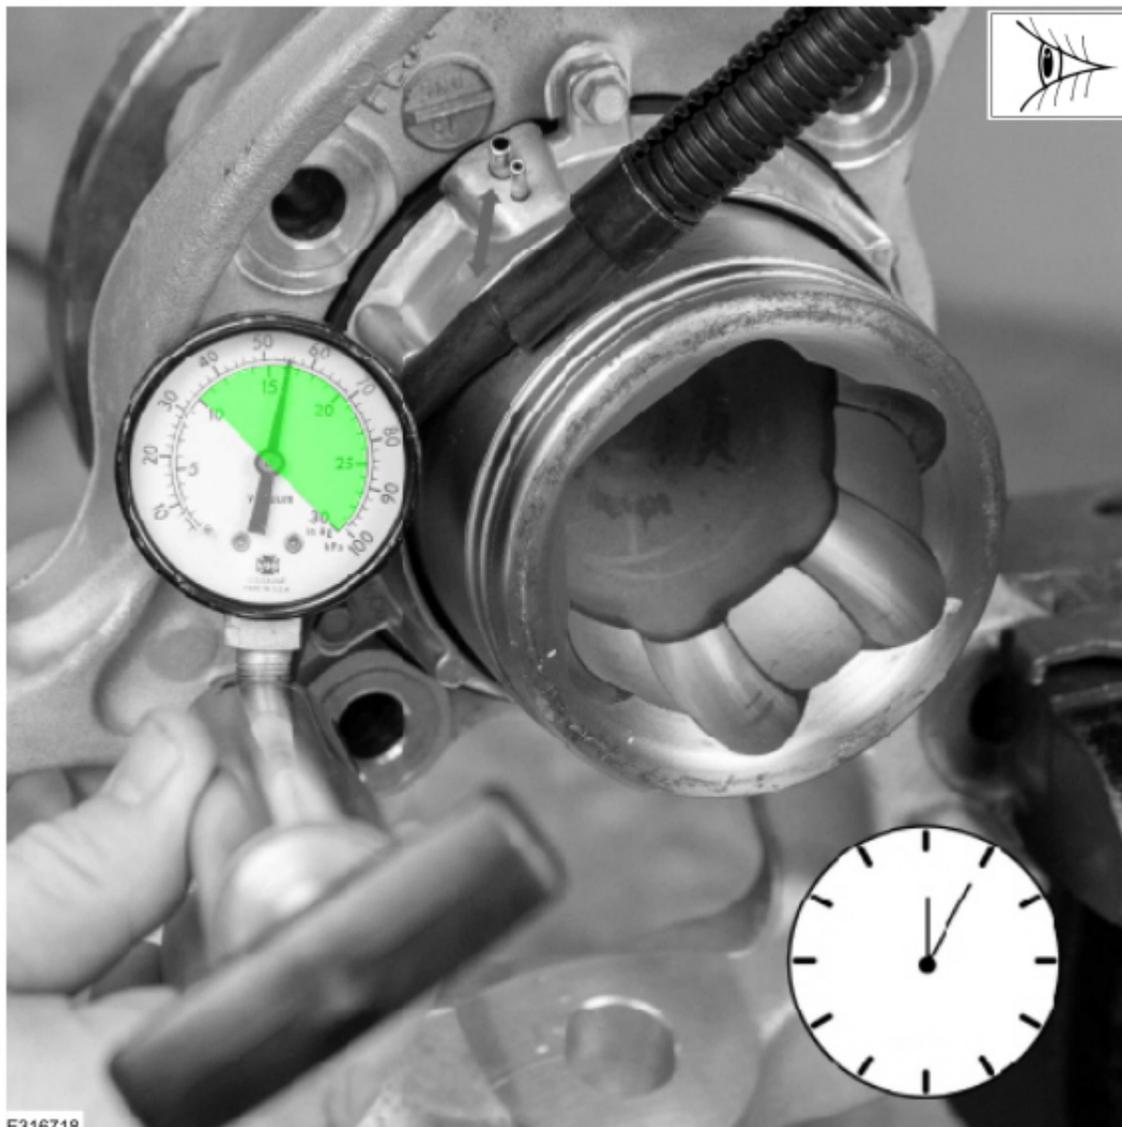
Figure 4

- (2). No - replace the IWE assembly. Refer to WSM, Section 308-07A. Proceed to Step 12.
- 10.** Test the IWE vacuum supply lines.
- (1). Disconnect the vacuum supply line at the left or right IWE and connect a vacuum gauge to the supply line as shown in Figure 4.

11. Is the vacuum at both left and right supply lines greater than 254 mm-Hg (10 in-Hg)?

(2). No - replace the vacuum lines between the solenoid and IWEs. Refer to the WSM, Section 308-07A. Proceed to Step 12.
